**DEPARTMENT OF TRANSPORTATION****DIVISION OF ENGINEERING SERVICES**

Quality Assurance and Source Inspection

Contract #: 04-0120F4Cty: SF/ALA Rte: 80 PM: 13.2/13.9File #: 69.28**WELDING INSPECTION REPORT****Resident Engineer:** Pursell, Gary**Address:** 333 Burma Road**City:** Oakland, CA 94607**Report No:** WIR-002517**Date Inspected:** 07-May-2008**Project Name:** SAS Superstructure**OSM Arrival Time:** 1400**Prime Contractor:** American Bridge/Fluor Enterprises, a JV**OSM Departure Time:** 2330**Contractor:** Zhenhua Port Machinery Company, Ltd (ZPMC), Changxing Island **Location:** Shanghai, China

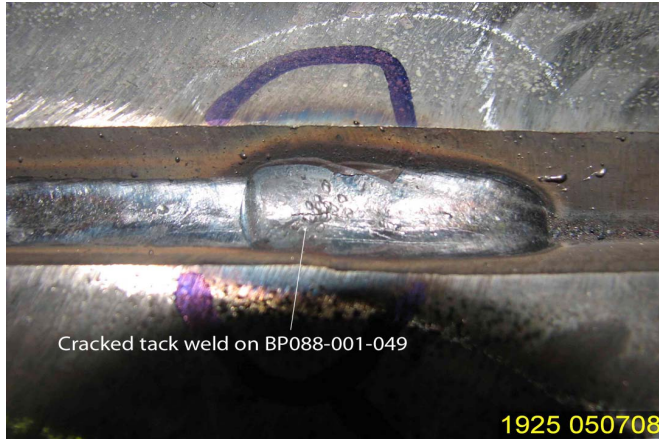
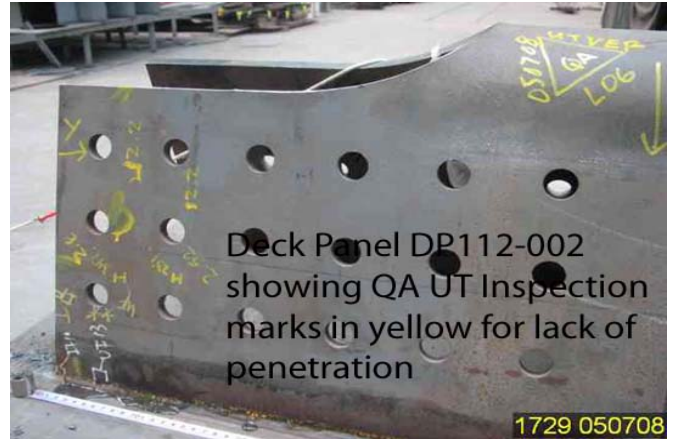
Bay 3: QA Inspector was informed by ZPMC QC Inspector Wang Lu that ABF Inspector Lu Xian Ling was monitoring FCAW tack welding on Bottom Plates BP088-001-049 and BP142-001-049 and noticed cracked tack welds. ABF Inspector asked ZPMC welder what he was going to do to fix the cracked tack welds. ZPMC welder did not believe the tack welds were cracked. QA Inspector arrived and verified that there were four (4) cracked tacks on BP088-001-049 and one (1) cracked tack on BP142-001-049. ZPMC QC Inspector informed QA Inspector that cracked tack welds would be removed by grinding and verify removal by magnetic particle (MT) inspection. ABF and QA Inspectors agreed that this is an acceptable repair to cracked tack welds. ZPMC, ABF and QA Inspectors witnessed grinding of cracked tack welds and MT inspection. Tack welds on bottom plates were found acceptable by ZPMC, ABF, and QA Inspectors.
